Figure 39 (continued). c) IRB98N1 and IRB98N2 boundaries with buffers, on IRB98N1 side-scan image. d) IRB98N1 and IRB98N2 boundaries with buffers.

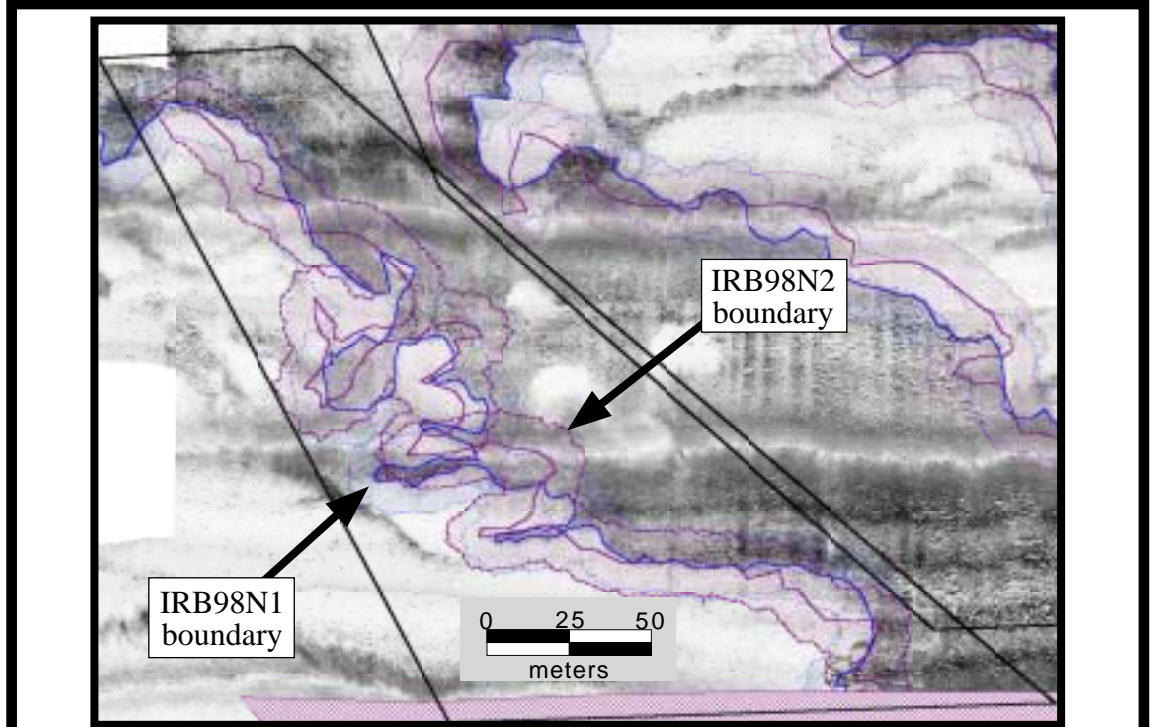
c) IRB98N1 and IRB98N2 boundaries with buffers, on IRB98N1 image.

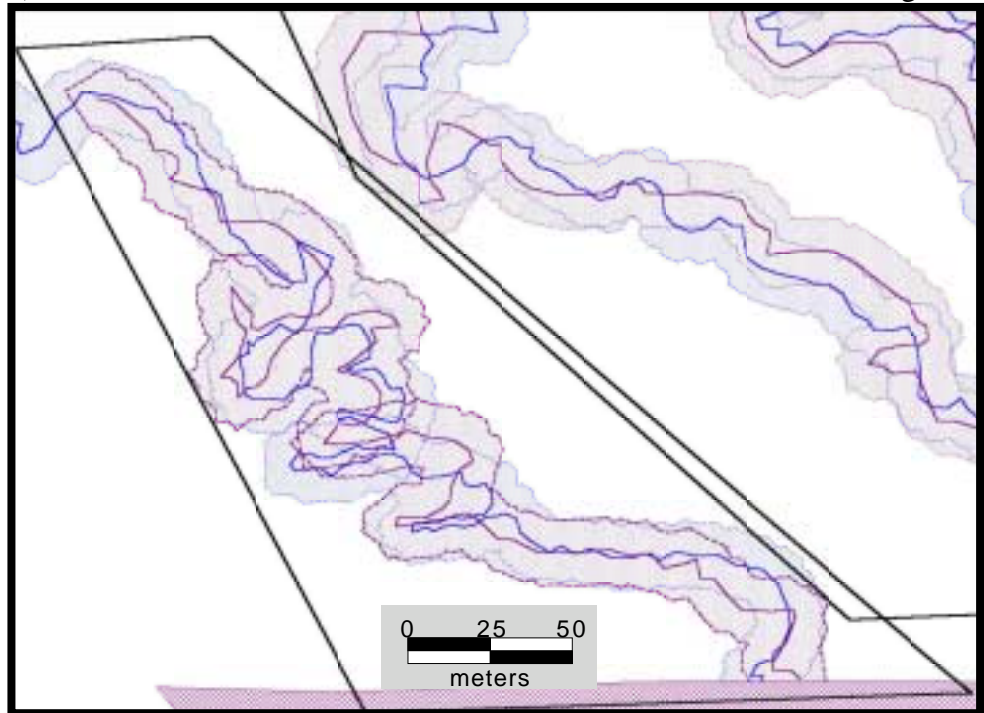
d) IRB98N1 and IRB98N2 boundaries with buffers. Boundary shifts between the two surveys were not consistently in one direction and showed no discernable patterns.
